## **Rack Inspection Report**

[REDACTED]  
[REDACTED] Facility  
[REDACTED]

# **Racking Damage Assessment**

# Section A

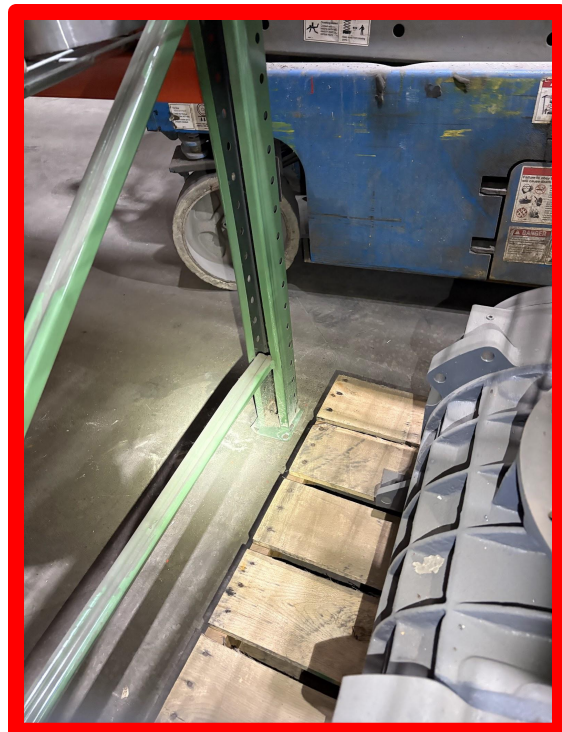
1CE, Bay 3  
Upright Missing Anchors <sup>4</sup>

### **4. Missing floor anchors**

The standard requires that the base of every column be furnished with a column base plate and that all rack columns be anchored to the floor. Anchor quantity, size, and embedment are determined by the rack design professional to resist the applicable forces, including uplift from impact and, where applicable, seismic demand. A column lacking its specified anchors does not develop the base fixity assumed in the frame design.

**Recommendation:** Install replacement anchors on uprights where bolts are missing or sheared.

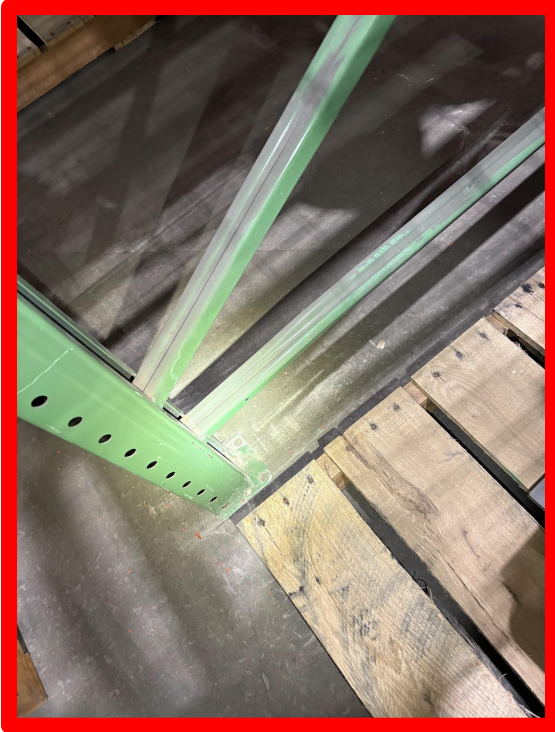
1CE, Bay 4  
Upright Missing Anchors <sup>4</sup>

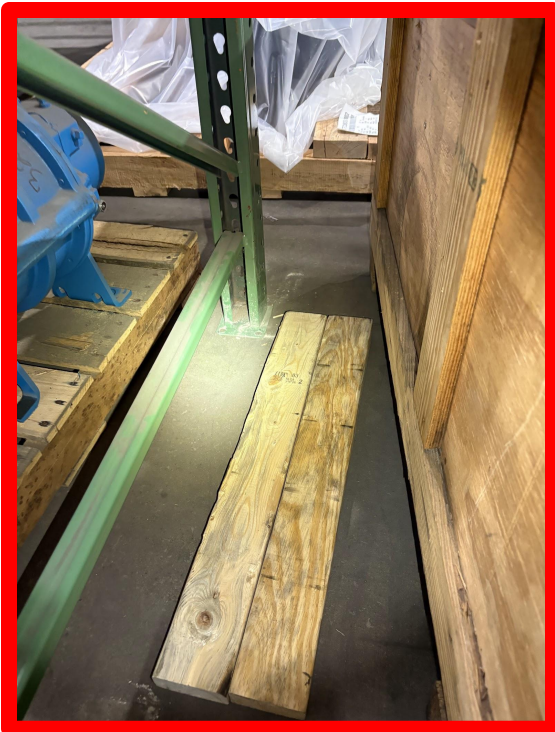
1CE, Bay 5  
Upright Missing Anchors <sup>4</sup>

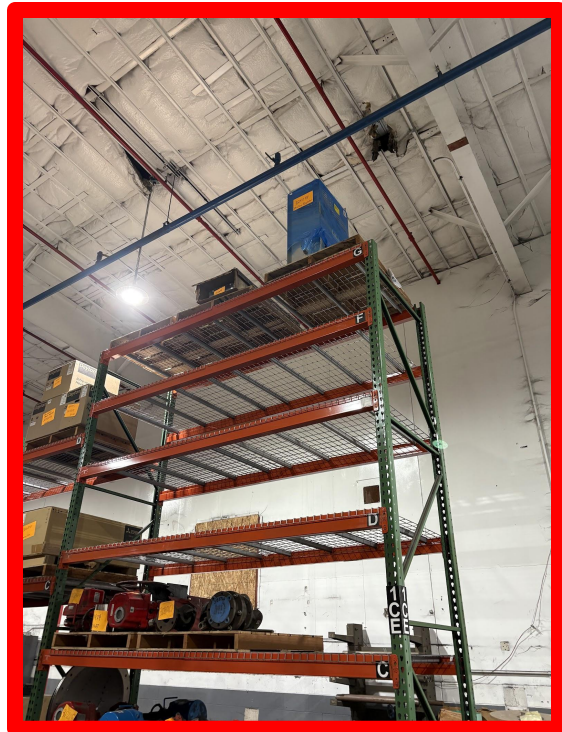
Ensure 18" minimum clearance. Loads should be distributed evenly across the full depth and width of the beam pair <sup>6</sup>

### **6. Uneven load distribution across the beam pair**

The standard directs owners to ensure that pallets are correctly placed onto load-supporting members in a properly stacked and stable position, and that goods on each pallet are themselves properly stacked and stable. Rack beam capacities are published on the basis of a uniformly distributed load applied across the full depth and width of the beam pair. Concentrated, offset, or single-beam loading produces bending and torsional demands not accounted for in the rated capacity, and the load application drawings furnished with the installation define the permissible configurations.
