## **Rack Inspection Report**

[REDACTED]  
[REDACTED] Facility  
[REDACTED]

# **Racking Damage Assessment**

# Section A

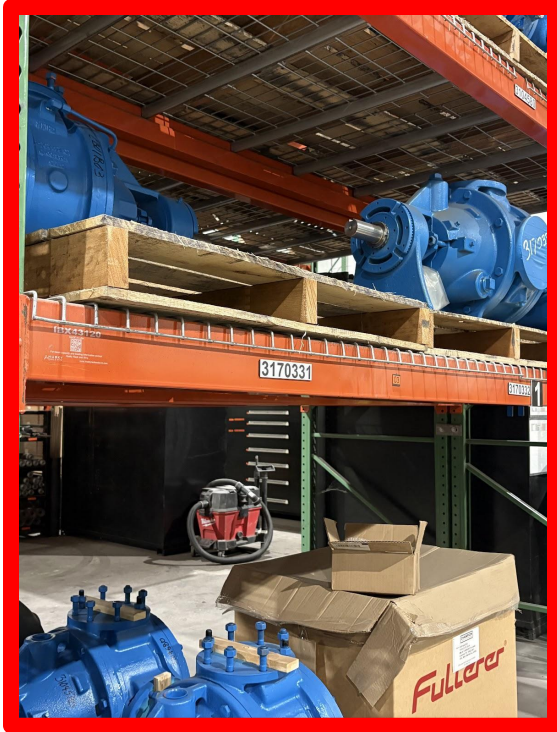
Row 1CB, Bay 1  
Beam deflection (Greater than 1/180 beam length) from overloading <sup>1</sup>

### **1. Beam deflection exceeding L/180**

The standard places responsibility on the owner to maintain the structural integrity of the installed system, including prohibiting overloading of any individual pallet position or of the rack system overall. Beam deflection measured in excess of 1/180 of the clear span under load indicates loading beyond the design assumption for that level, and is treated in this report as an overloading condition rather than a manufacturing defect.

Measurement criterion: maximum permissible deflection = clear beam span ÷ 180, measured under load at midspan.

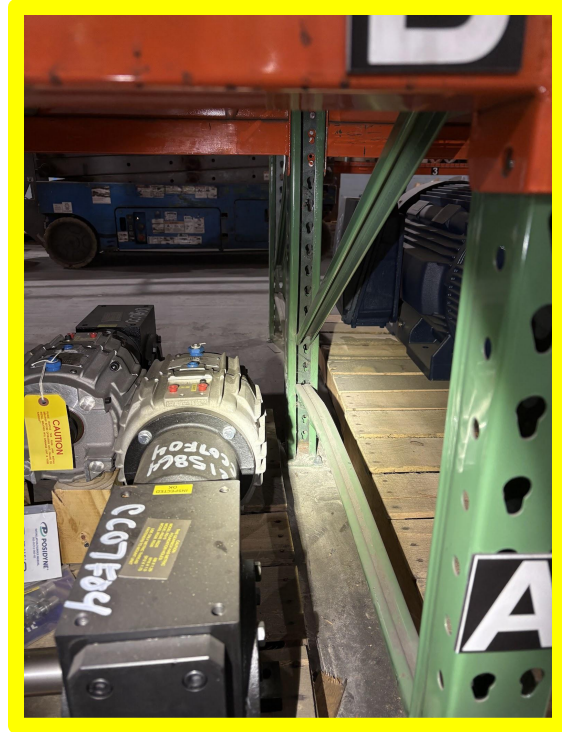
Row 1CB, Bay 1  
Damaged Horizontal Brace <sup>2</sup>

### **2. Damaged upright bracing**

Where visible damage is present, the standard directs that the affected portion of the rack be isolated immediately and evaluated by a storage rack design professional. Damaged structural components are to be unloaded and then repaired or replaced as directed by that professional, so that the system is restored to no less than its original design capacity. Diagonal and horizontal bracing members are structural components of the upright frame; damage to them reduces frame capacity irrespective of the condition of the columns themselves.

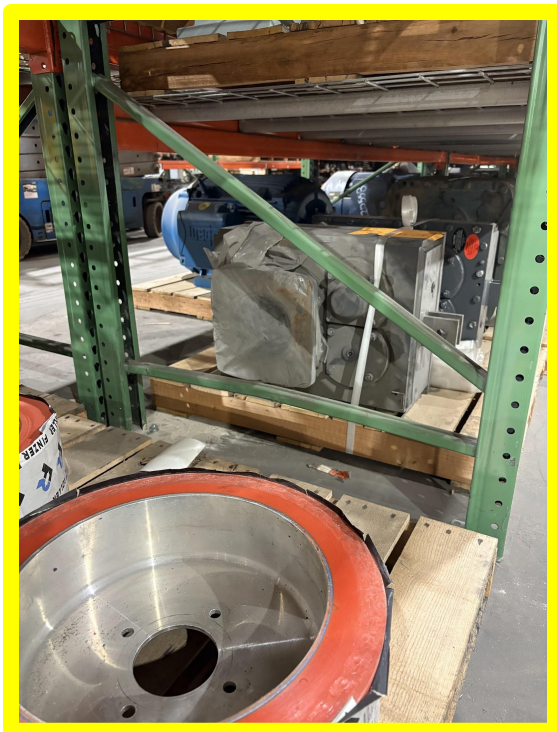
Row 1CB, Bay 5  
Damaged Horizontal Brace <sup>2</sup>

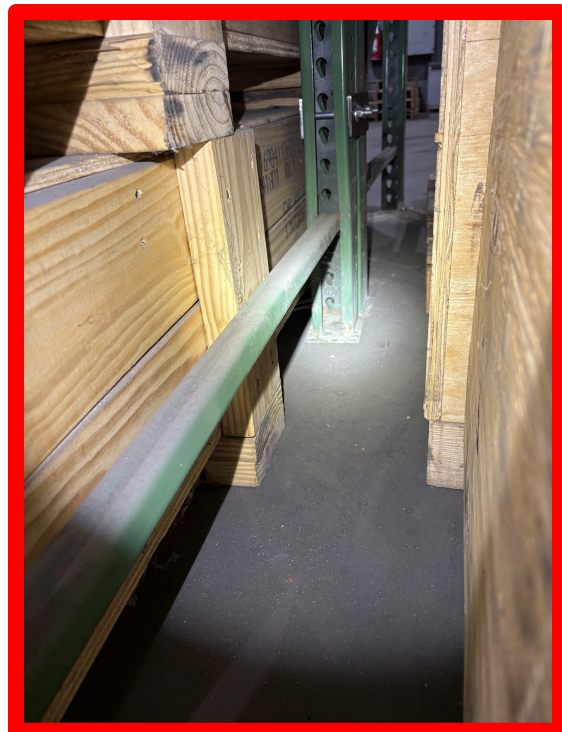
Row 1CB, Bay 5  
Upright Missing Anchors <sup>4</sup>

### **4. Missing floor anchors**

The standard requires that the base of every column be furnished with a column base plate and that all rack columns be anchored to the floor. Anchor quantity, size, and embedment are determined by the rack design professional to resist the applicable forces, including uplift from impact and, where applicable, seismic demand. A column lacking its specified anchors does not develop the base fixity assumed in the frame design.

**Recommendation:** Install replacement anchors on uprights where bolts are missing or sheared.

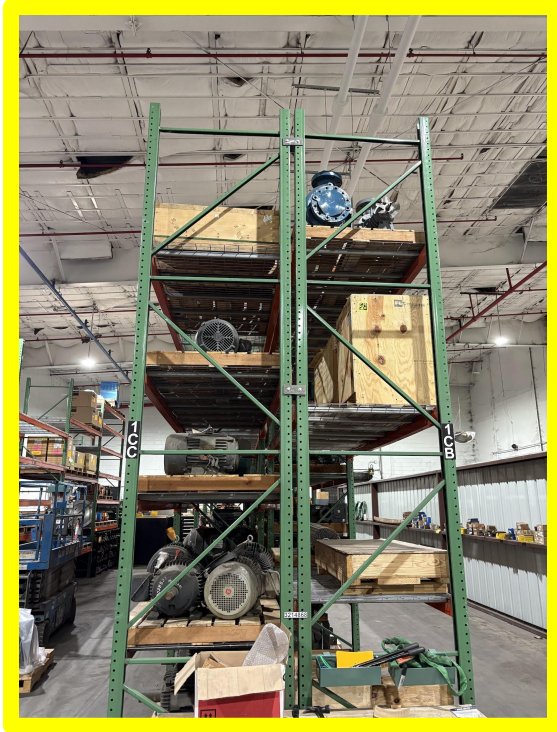
Rows 1CC & 1CB  
Longitudinal flue space less than 3"  
minimum between rows (NFPA 13) <sup>8</sup>

### 8. Obstructed flue space

Flue spaces permit vertical heat transfer to ceiling sprinklers and downward water penetration into the rack. Required dimensions depend on the flue type, the storage arrangement, the commodity class, and the sprinkler design basis, and vary by NFPA 13 edition. Applicable dimensional requirements and the edition applied are recorded with the individual finding.

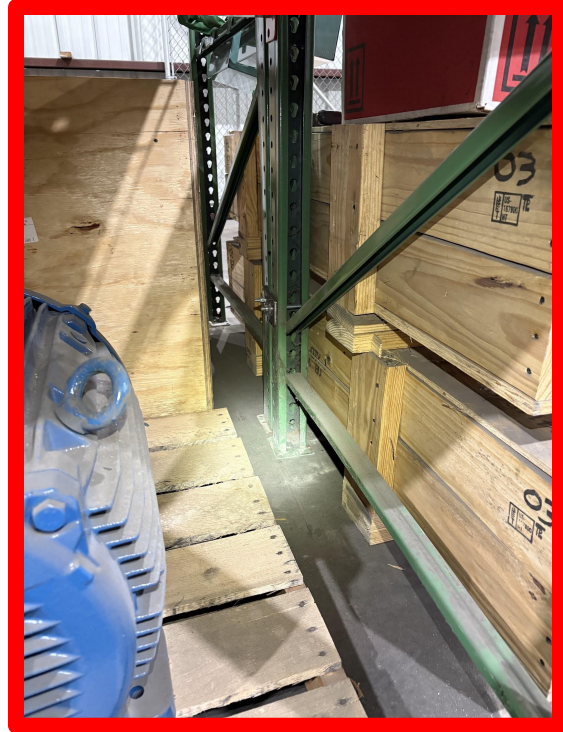
1CC, Bay 5  
Upright Missing Anchors <sup>4</sup>

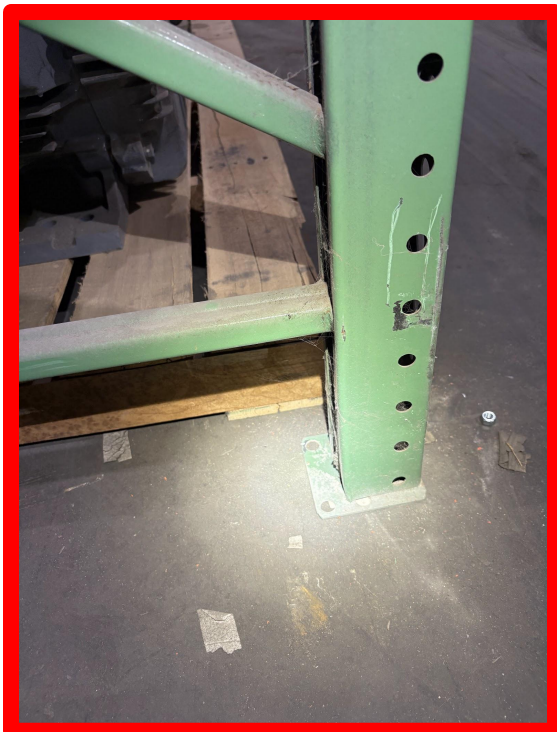
1CC, Bay 4  
Upright Missing Anchors <sup>4</sup>

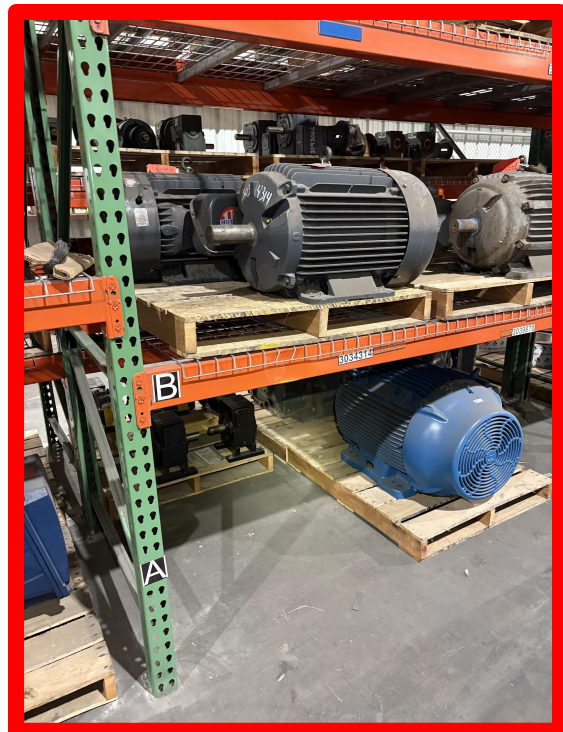
1CC, Bay 4  
Damaged Beam <sup>3</sup>

### **3. Damaged beam**

As above. Deformation, cracking, tearing, or denting of a horizontal load-supporting member reduces its load-carrying capacity. The affected bay is to be isolated and evaluated before being returned to service.

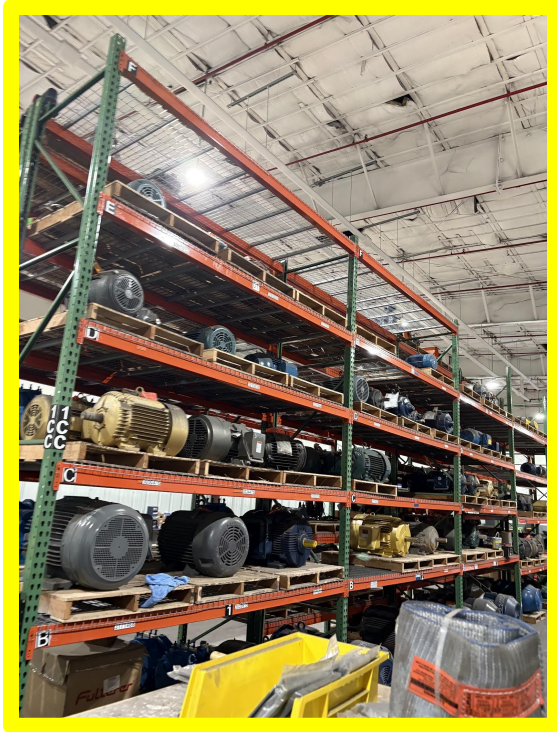
Ensure 18" minimum clearance between top of palletized load and sprinkler deflectors (NFPA 13) <sup>7</sup>

### 7. Clearance between top of storage and sprinkler deflectors

A minimum of 18 inches of clear space is required between the top of stored material and sprinkler deflectors, so that discharge is not obstructed. OSHA states this requirement independently of NFPA 13, which makes it directly citable as a federal regulatory requirement rather than solely as consensus practice. The applicable NFPA 13 edition is stated on the report cover page.

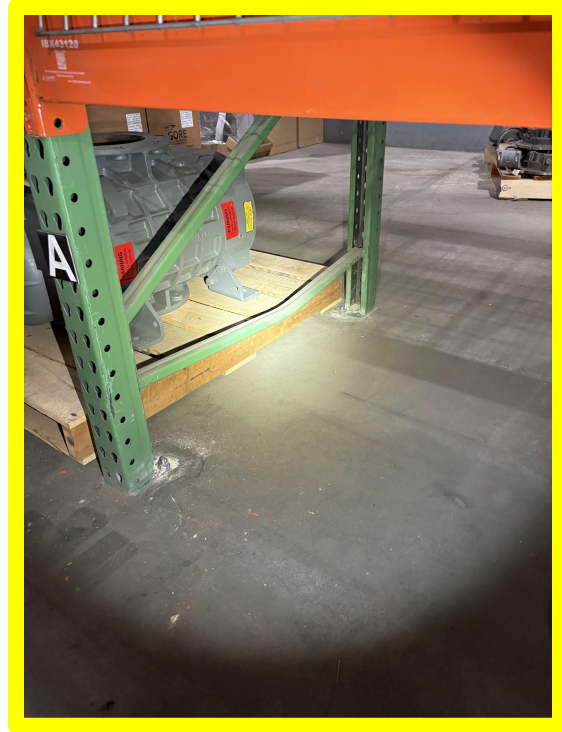
1CE, Bay 2  
Damaged Horizontal Brace <sup>2</sup>

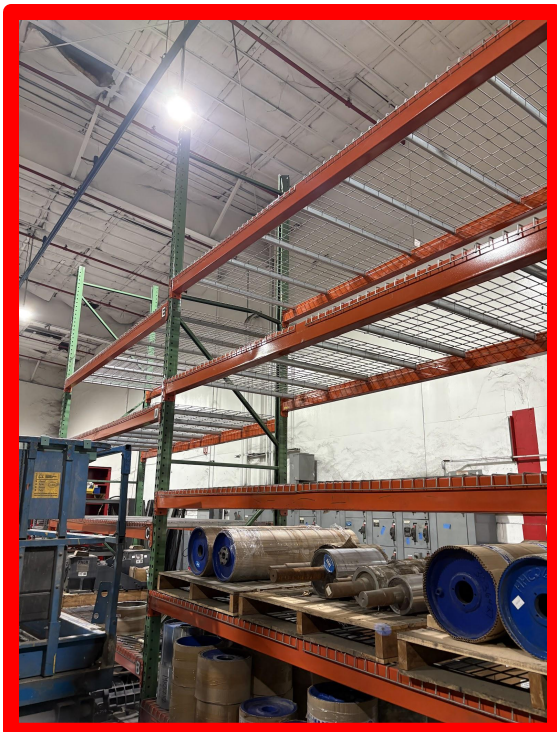
1CE, Bay 3  
Beam Damage <sup>3</sup>

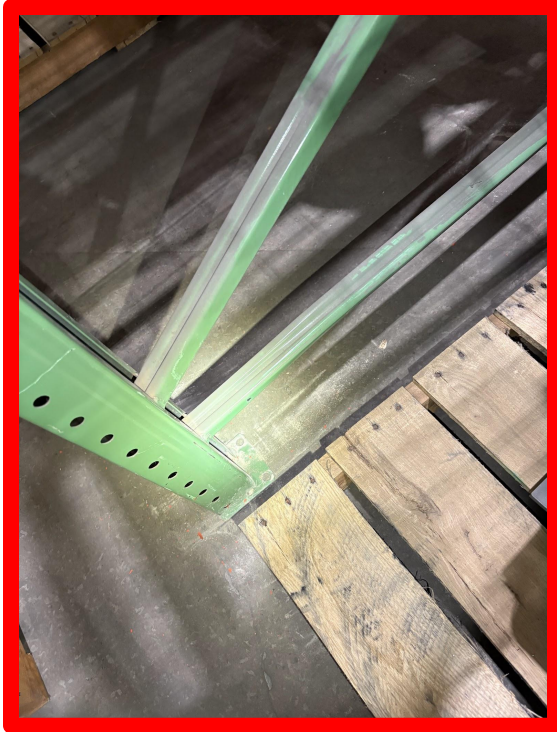
1CE, Bay 4  
Upright Missing Anchors <sup>4</sup>

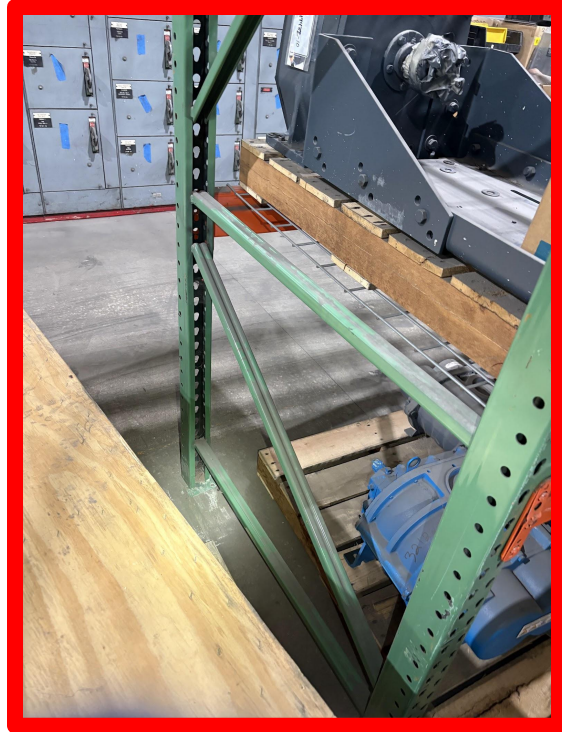
1CE, Bay 5  
Upright Missing Anchors <sup>4</sup>

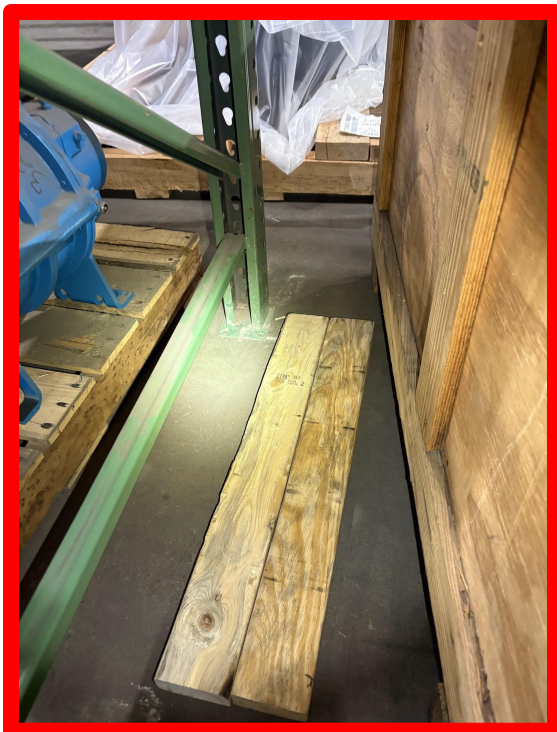
1CE, Bay 5  
Upright Missing Anchors <sup>4</sup>

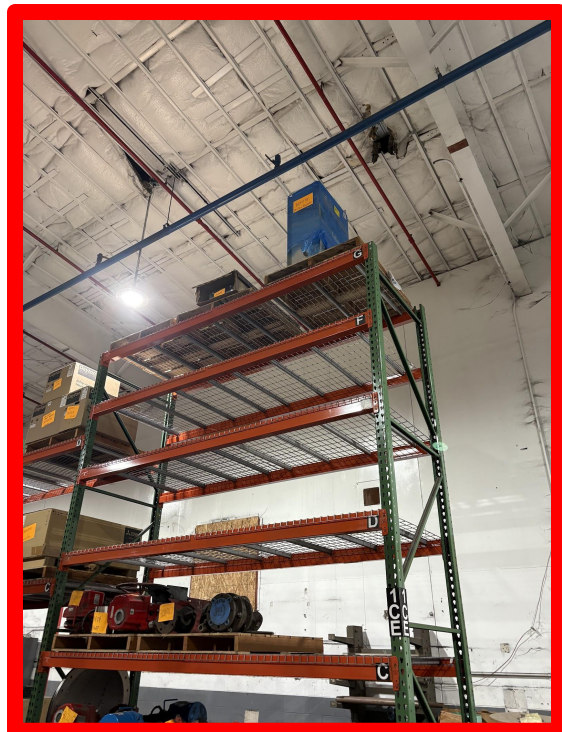
Ensure 18" minimum clearance. Loads should be distributed evenly across the full depth and width of the beam pair <sup>6</sup>

### **6. Uneven load distribution across the beam pair**

The standard directs owners to ensure that pallets are correctly placed onto load-supporting members in a properly stacked and stable position, and that goods on each pallet are themselves properly stacked and stable. Rack beam capacities are published on the basis of a uniformly distributed load applied across the full depth and width of the beam pair. Concentrated, offset, or single-beam loading produces bending and torsional demands not accounted for in the rated capacity, and the load application drawings furnished with the installation define the permissible configurations.

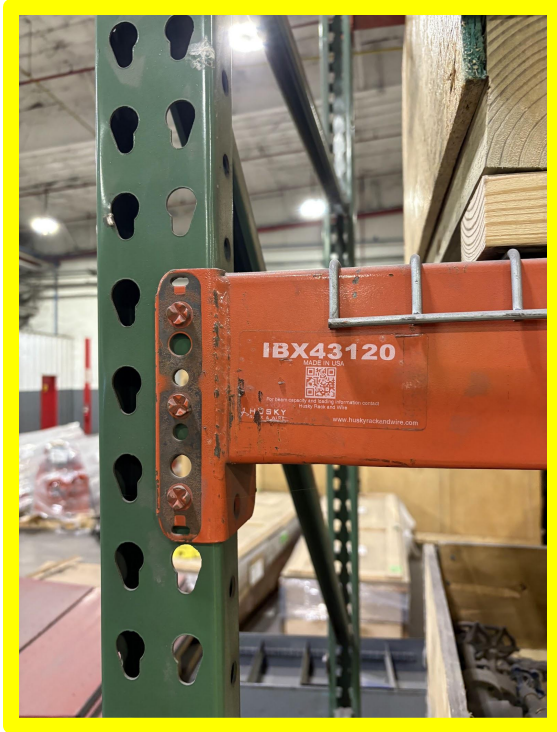
Missing Safety Clips <sup>5</sup>

### **5. Missing beam connection safety clips**

The standard requires that beams subject to machine loading be fitted with connection locking devices or bolts able to resist an upward force of 1,000 lbf (4,450 N) per connection without failing or disengaging. The locking device prevents beam dislodgement from upward impact during pallet placement or retrieval. A connection missing its locking device does not meet this requirement regardless of the condition of the beam or the column.

Criterion: 1,000 lbf (4,450 N) uplift resistance per connection.
